PROPERTIES OF HIGH VOLUME FLY ASH WALL CONCRETE

**Little Mountain Reservoir
Vancouver, BC**

Combined Phase I and Phase II Report

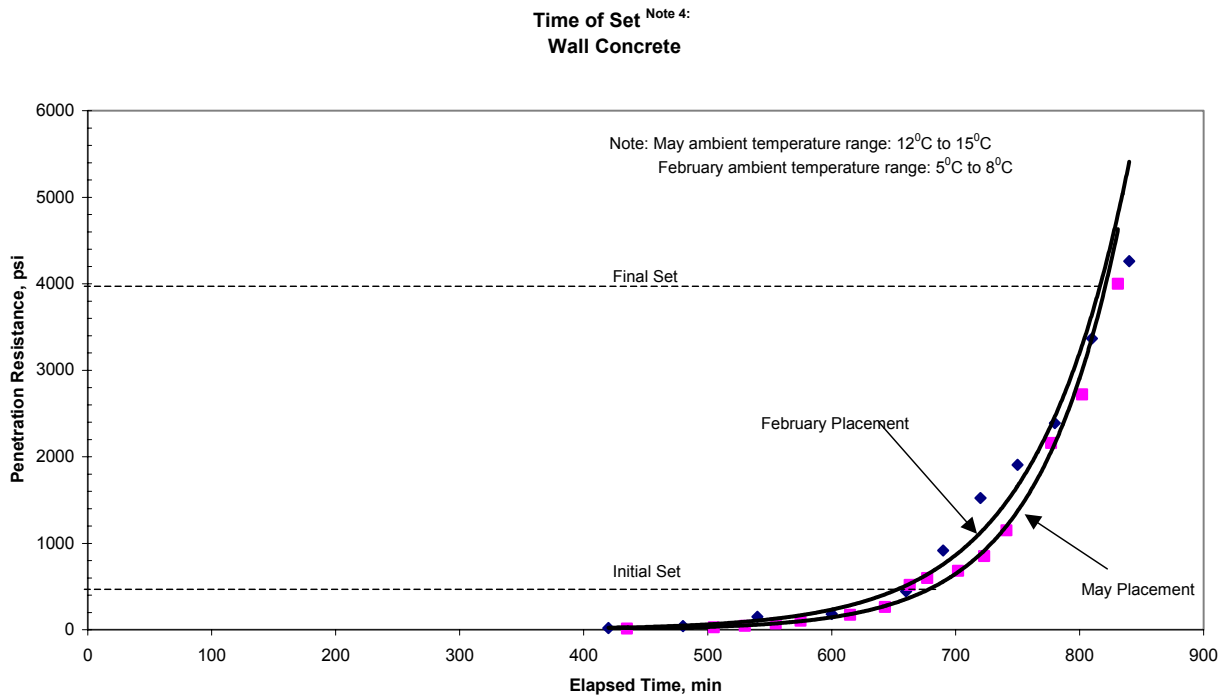
Fig. 1 Setting Time

The setting times are shown in Fig. 1. An Initial Set of about 11 hours and a Final Set of about 14 hours is recorded.

Slow setting times are evident in Fig. 1. These occurred despite good initial plastic temperatures of about 17°C. Both the Phase I and II mixtures performed in a similar way; this is not surprising considering that the ambient temperature regimes at sampling were also similar. In this case there are compensating factors in Phase II vs Phase I:

The Initial Set of the mixtures was in the order of 11 hours and the Final Set in the order of 13-1/2 hours. Conventional concrete with the normal fly ash content in the order of 20% would be expected to have setting times significantly less with an Initial Set in the order of 9 hours at the temperatures here. The increased setting time is largely due to the higher fly ash replacement contents of this concrete although the presence of superplasticizer may have had a small contribution.

The setting time test is conducted on a small sample stored at ambient conditions which were temperatures of 9°C or less in this case. Therefore, these samples cool much more quickly than the concrete in the relatively massive wall (see Fig. 5) and the in situ setting times for the wall concrete would therefore be shorter.

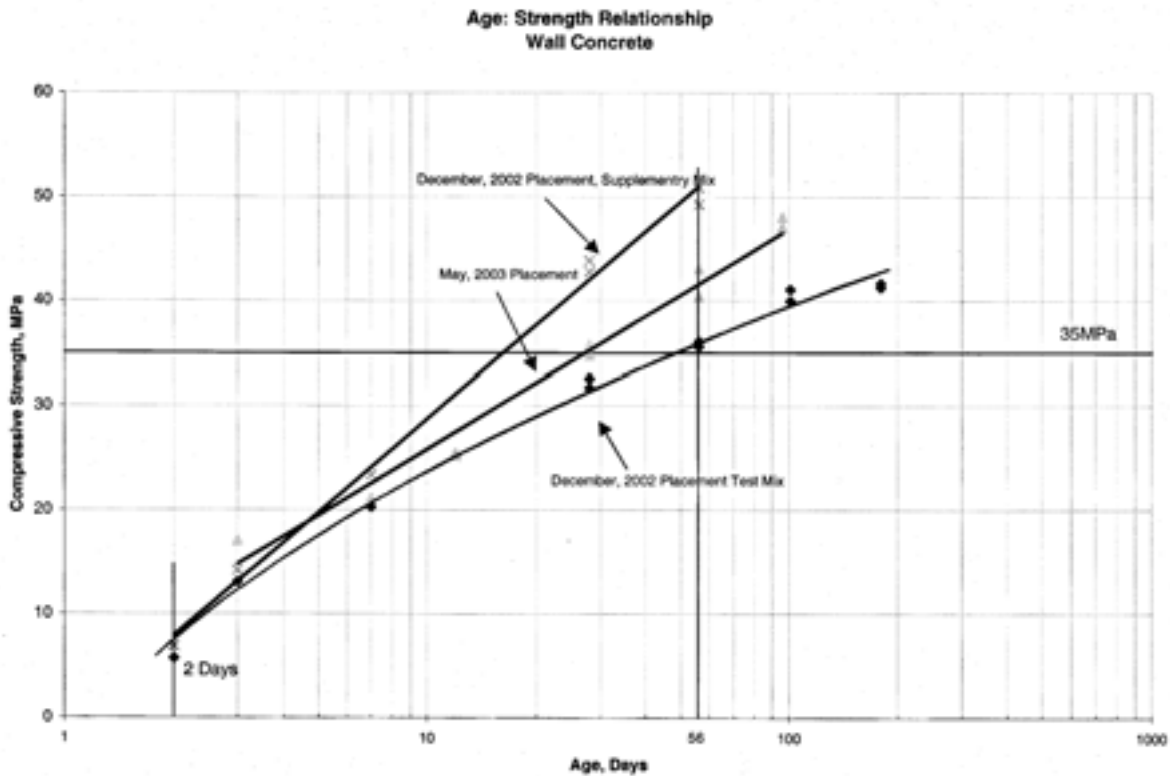
Fig. 2 Age:Strength Results for the Two Samples

Fig. 2 presents age:strength results for the three samplings. Results are presented in a semi-log plot because previous experience with similar EcoSmart concrete had shown the classical linearity in this form.

The large discrepancy between the results of the Phase I Test and Supplementary mixes is explained in 5.3.

The Fig. 2 data shows a significant range in the 56 day strengths of the three mixtures. Reference to project quality control test results indicates that the average strength of these mixtures is typically in the 48 MPa range, while the required strength is 35 MPa.

Comparing the slopes of the age:strength curves, Fig. 2 of the Phase I Supplementary and Phase II Mixes shows the flatter slope of the latter. This is a reflection of the higher fly ash content.

With regard to Compressive Strength gain with time, and excluding the Phase I Test Mix for reasons indicated above, Fig. 2 shows:

- a 7:56 day strength ratio in the order of 50%;
- a 28:56 day strength ratio in the order of 83%.

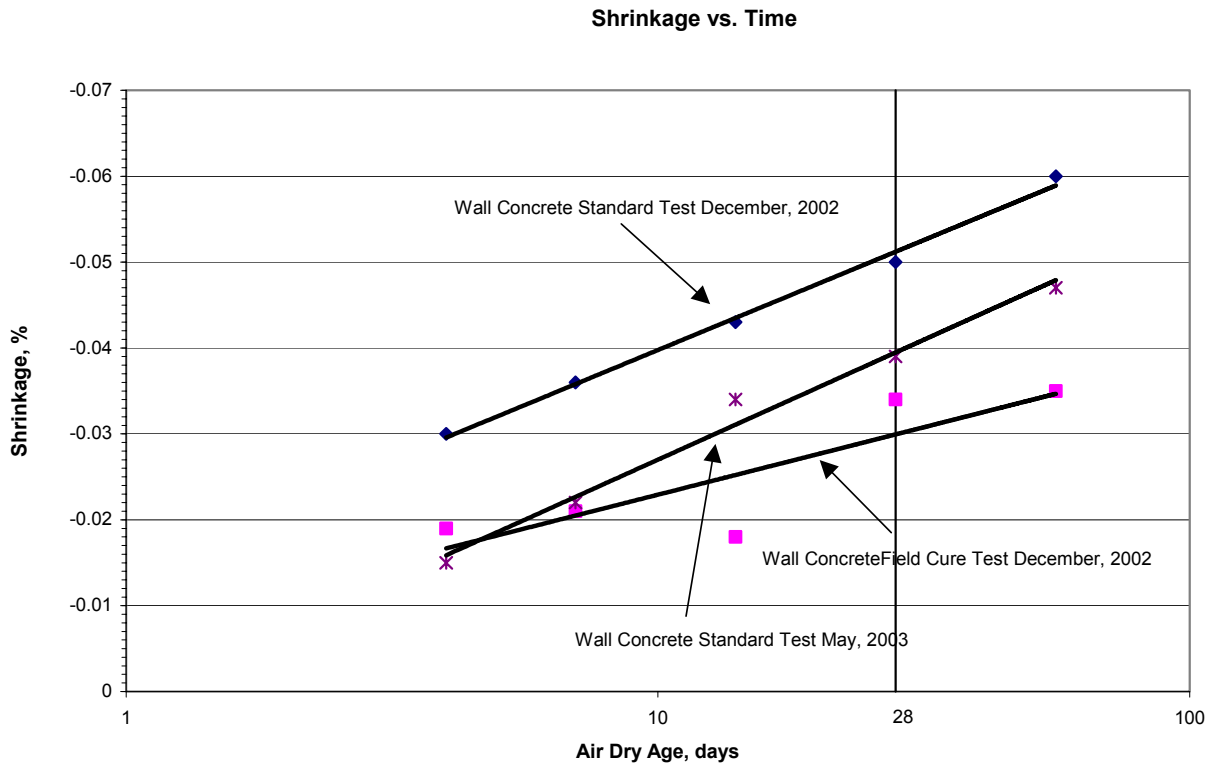
Fig. 4 Shrinkage

Refer to Fig. 4.

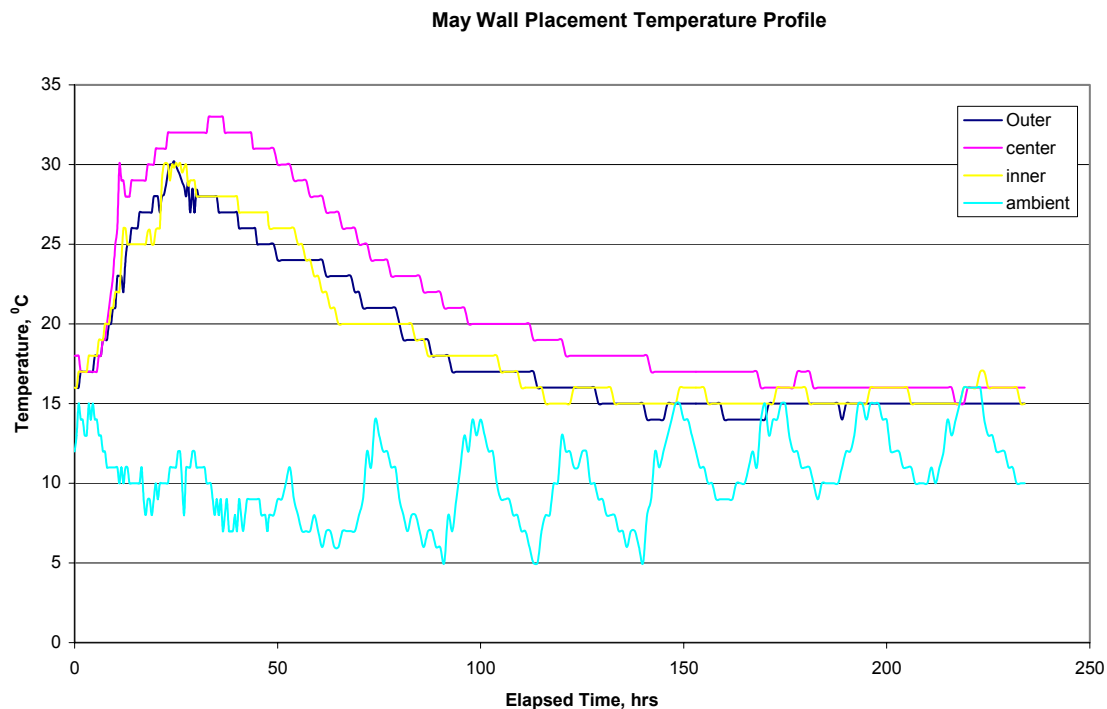
Fig. 5 In Situ Temperature Profile of Wall Concrete

Fig. 5 shows the temperature profiles. Peak temperatures were reached in about 25 hours and returned to a stable value in about 100 hours.

Information in Fig. 5 shows the expected reduction in maximum temperature when using concrete with higher volumes of fly ash replacement. The maximum temperature in the centre of the wall of about 33°C is substantially lower than what would be expected for conventional concrete with 25% fly ash; data from other projects indicates that such concrete would have values at least 10°C higher.

These temperatures are monitored because they present a procedure for estimating the potential for thermal cracking. The important parameter is the difference in temperature between the ambient, which represents the exposed surfaces of the concrete, and the internal temperature. Recommendations in various ACI documents limit this differential to 20°C; Levelton has found that differentials up to 25°C can normally be accepted. In this case, the temperature differential easily meets the ACI limits.

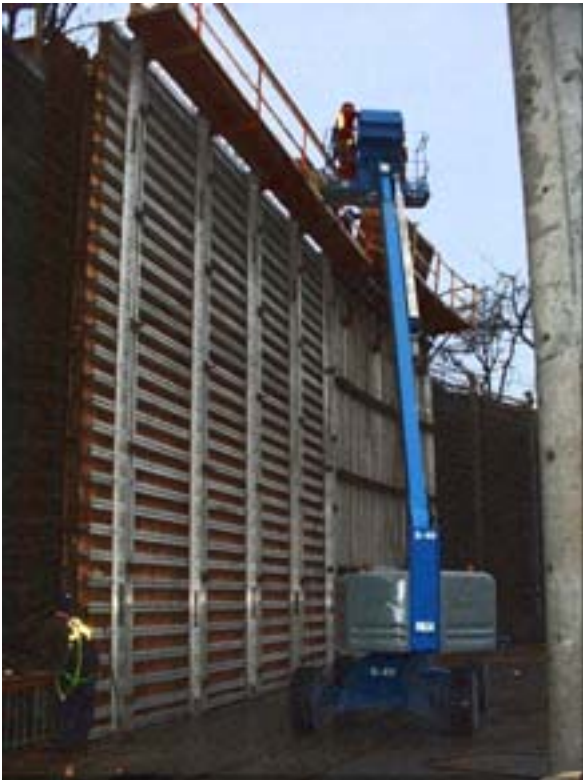
Photograph 3
Wall forming system. Installing thermocouples and maturity gauges.

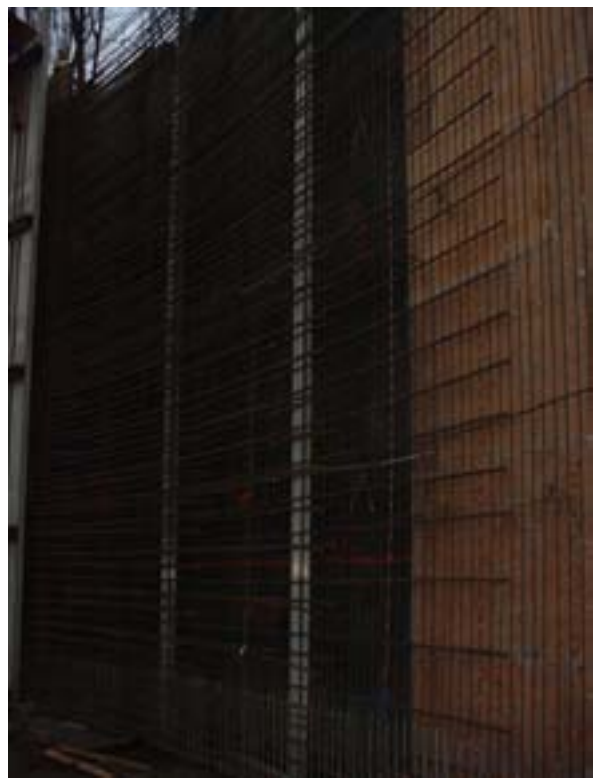
Photograph 4
Wall reinforcement.

Reinforcement congestion is shown in Photographs 4 and 14.

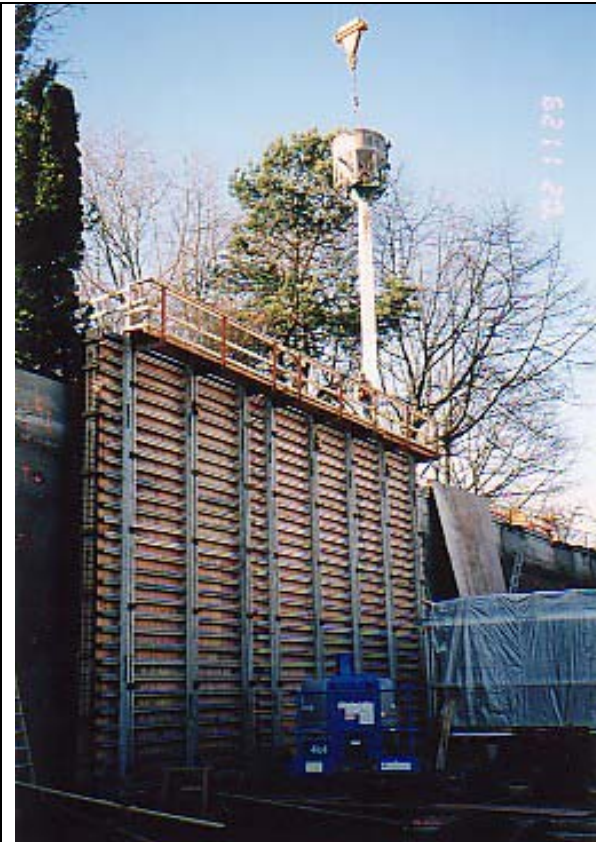
Photograph 5
Phase I. Concrete Placement in Wall.

Graham Construction, the Contractor, placed Phase I concrete with a crane and bucket into drop chutes – see Photograph 5. The Phase I test wall was the third that had been placed by Graham. Because of the Contractor's success in placing and consolidating concrete in early stages, changes were made in later concreting. These consisted of:

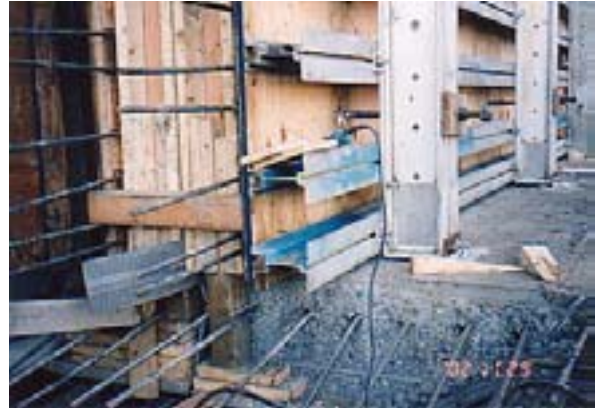
Photograph 6
Wall base detail showing waterstop and two curtains of dowels.

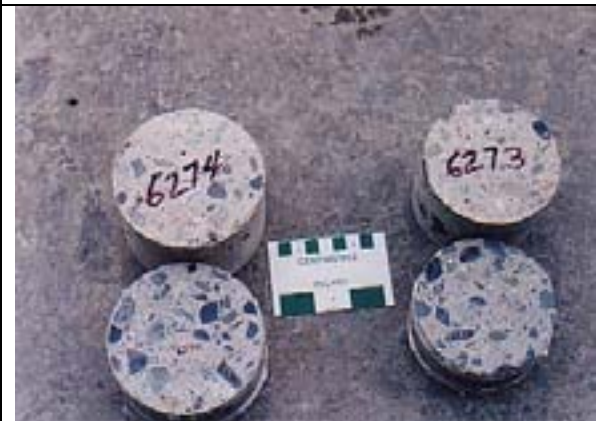
Photograph 7
Cylinders prepared for Phase I RCP test. Lower faces polished. #6273 is Test Mix; #6274 is Supplementary Mix.

Photograph 7 shows the structure of the Phase I Test and Supplementary Mix concretes.

Photograph 7 compares the structure of the Phase I Test and Supplementary Mixes. It is noted that there is a markedly lower coarse aggregate content in the former. In order to investigate this difference further, Levelton undertook a test to determine the coarse aggregate content of the two Mixes. Test cylinders were broken down in a muffle furnace and both the coarse aggregate weight and cement contents (based on ASTM C1084 procedures for analysis of CaO) were determined. Results were:

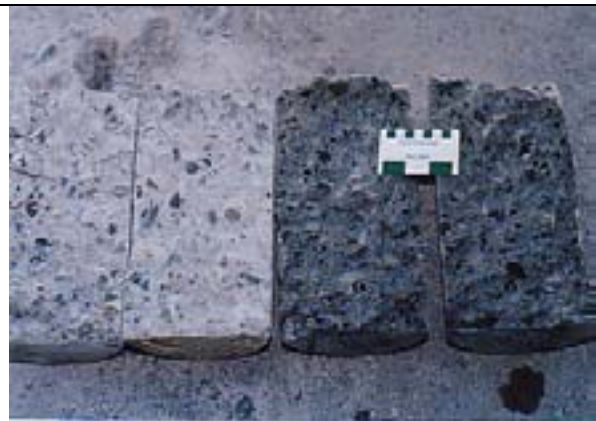
Photograph 8
Split tensile test cylinders after testing. Right = Wet. Left = Dry.

f_{sp} values translate to about 9% of compressive strength which is normal. Failure patterns showed:

- some aggregate fracture;
- a few noticeable unsound aggregate particles;
- volcanic aggregate with mineral-filled cracks.

Photographs 8 and 9 illustrate.

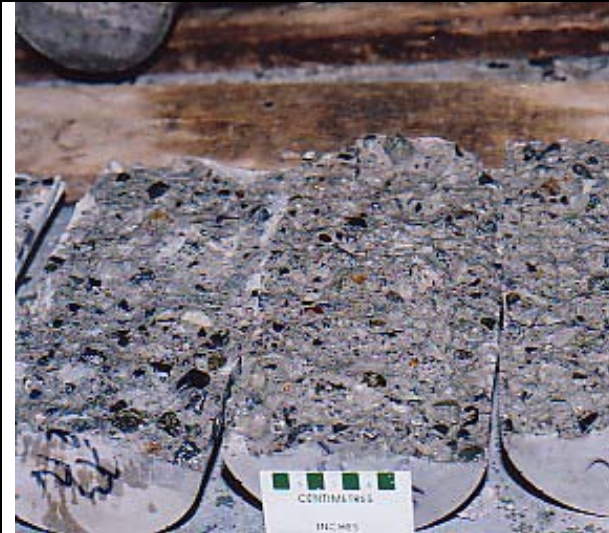
Photograph 9
Close-up of Photograph 8. Note some coarse aggregate fractured but most failed in paste:aggregate bond.

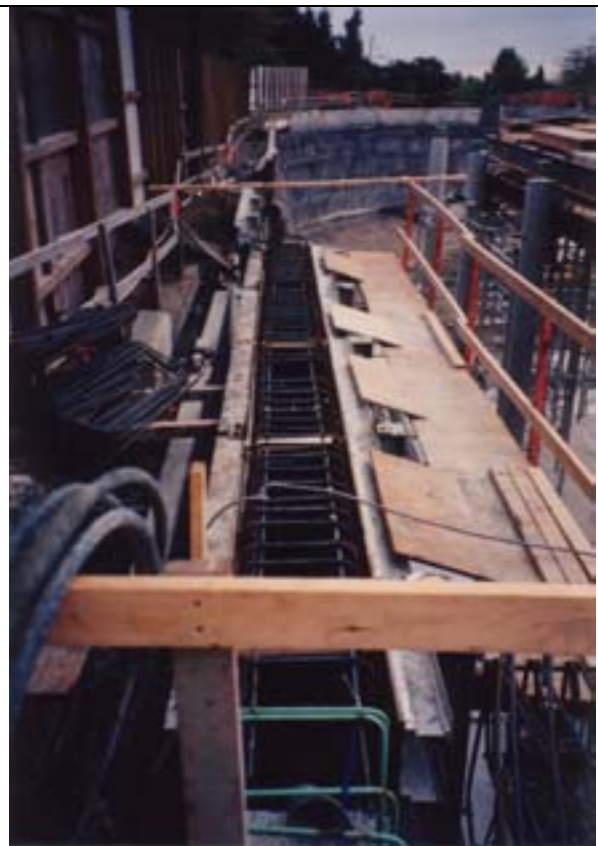
Photograph 12
Top of Wall. Wire in foreground is for thermocouples.

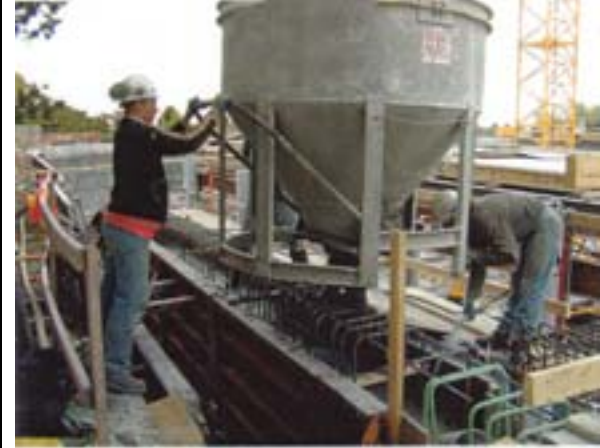
Photograph 13
Placing and vibrating concrete.

1. direct placement from a bucket – see Photograph 13 for Phase II;
2. because of the desire to maximize early strength gain, Graham requested, and received permission to reduce the superplasticizer dosage such that the slump was in the 120 mm range.^{Note 1:} The 180 mm had been specified to both minimize the need for consolidation, given the wall height, and to ensure encapsulation around the waterstop connecting to the foundation. The 120 mm slump in the high volume fly ash concrete here achieved these objectives equally well.
