**THE LO RESIDENCE
CASE STUDY**

THE USE OF HIGH VOLUME FLY ASH CONCRETE
AT THE LO RESIDENCE

Prepared by: Roland Haebler, M.A.Sc., P.Eng.
THE HAEBLER GROUP, GENERAL CONTRACTORS

March 31, 2003

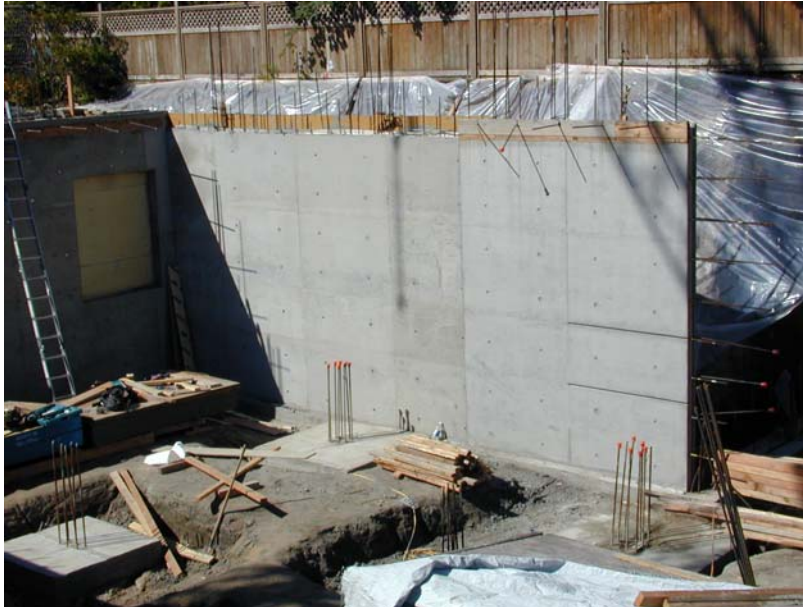
Figure 1: Initial Test Wall Showing 3 Plywood Surfaces

Figure 1 shows the first test pour, with 3 different plywood surfaces. The panel at the right utilized high density overlay plywood, and it can be seen that it provides a lighter colored surface finish. The panels at the left utilize medium density overlay plywood. Figure 2 shows a portion of the exposed walls above grade that will remain part of the finished project. This surface is a “as cast” surface, with no patching or remedial work having been done.

Test pours were made on site using a variety of form plywood, and with slight modifications to the actual mix. Different types of Form Plywood will produce variations in the finished surface. After about 10 test pours it was decided to use a modified HC1 mix that used a water reducing agent, as well as to utilize 14mm pea gravel type aggregate in lieu of the normal 20mm crushed stone, along with a High Density Overlay Plywood as the form surface.

The test pours indicated that using the smaller aggregate produced a finer and denser surface finish. As well, since many of the exposed walls would be 12” thick, with 4” of rigid insulation in the center, it was felt that utilizing a mix with a smaller aggregate would make the pouring process easier and improve the consolidation of concrete around the reinforcing steel. However, as will be seen in Table 2, using the 14mm aggregate was most likely the reason why the Lo Residence mix did not achieve as high compressive strength test results as previous HVFA mixes. This is because much of the compressive strength of concrete is directly related to the strength of the coarse aggregate.

The test pours were such a success, especially utilizing the high density overlay plywood, that it was decided to delete the originally specified sandblasting and to keep the concrete surface “Form Fresh”. Deleting the sandblasting resulted in a further labour and material cost saving, that was achievable only by utilizing the HVFA mix.

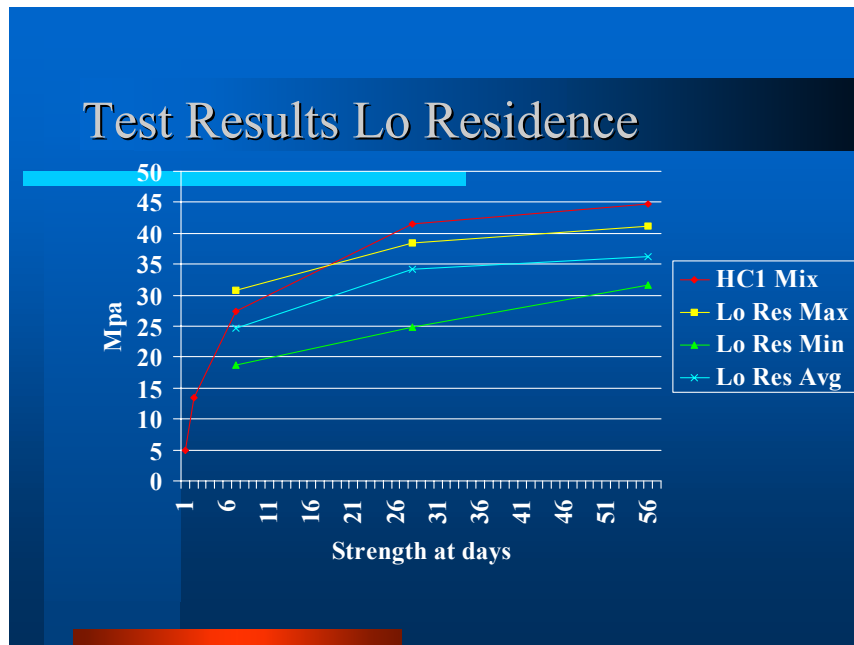
Figure 3: Test Results of Lo Residence HVFA Mix as Compared to HC1 Mix

The actual test results for all concrete tested using the HVFA mix are shown in Appendix A. Figure 3 shows a summary of the results compared to the HVFA mix used at The Waterfall building. As can be seen the average maximum values for the Lo Residence mix achieved lower strength characteristics than the initial HC1 mix. Since the strength in any concrete mix is in large part related to the strength of the aggregate, the author suspects that it was the use of the 14mm aggregate for aesthetic reasons that resulted in this lower strength. However, the actual test results do show that even the minimum test results are above the specified 30MPa at 56 days requirement.

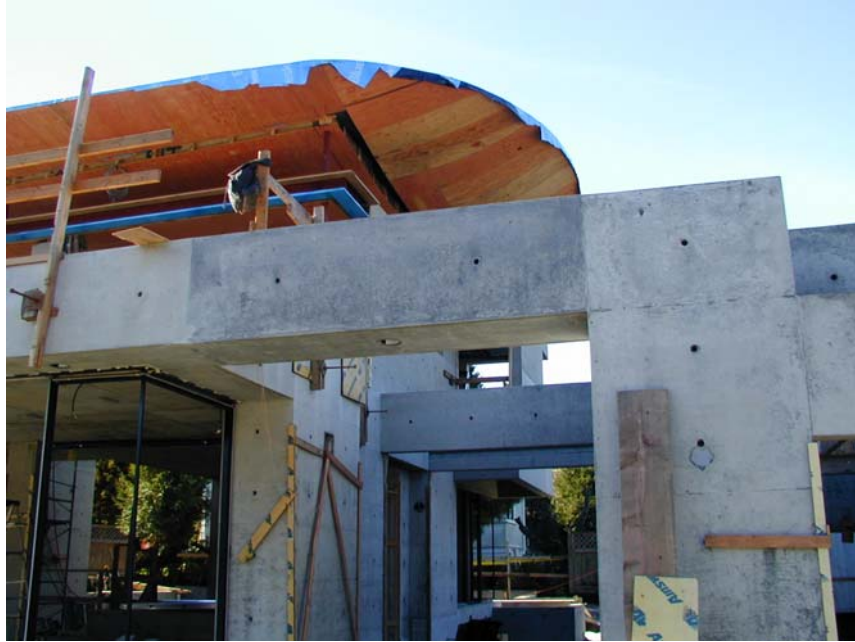
Figure 4: Discolored HVFA Concrete Panel Poured during Cold Weather Period

Figure 4 shows an example of this discoloration, this being the spandrel beam which was poured in November well after the main house portion on the left, or the garage portion on the right. Note that temporary heat was utilized on the panel on the right for 3 to 4 days and some lightening of the concrete occurred. We are therefore hopeful that the colour will lighten more once the concrete warms up in the summer.

As has been mentioned by the author in previous reports and presentations, HVFA concrete does not appear to produce acceptable curing and aesthetic qualities in cold weather conditions. This is related to a number of factors. Firstly, because of the high amount of fly ash in the mix, the HVFA mix will set up much slower than conventional mixes. Secondly, there appears to be a tendency of the HVFA to bleed more water to the surface of the form, which in some way results in a stained surface texture.

Continued problems seem to occur with the surface finish of HVFA concrete mixes when used in cold weather periods. The most noticeable problem is a darkening and discolouration of the finished and exposed surface, which was immediately noticeable once the forms were removed. We are hopeful that once the concrete warms up in the spring some of this darkened concrete will lighten in colour.

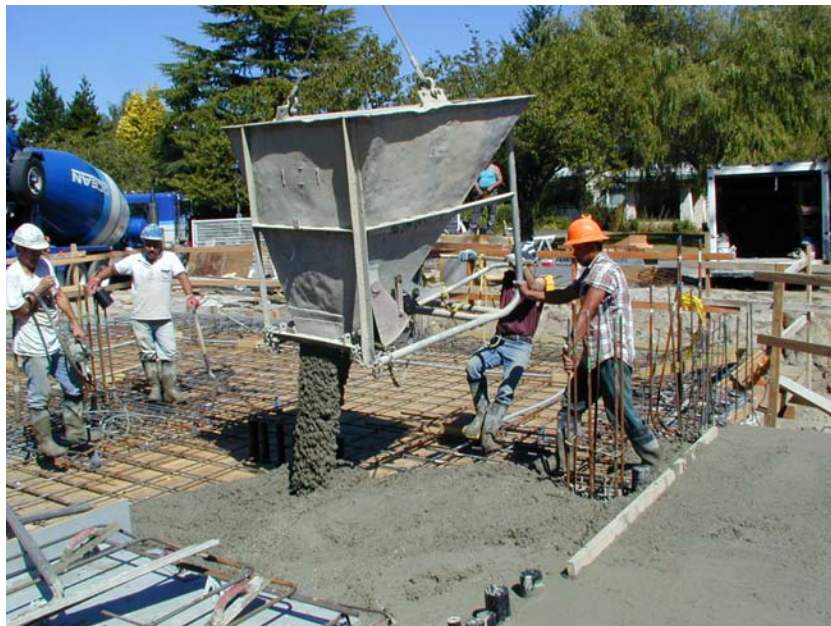
Figure 5: Pouring First Slab with Concrete Bucket

Following are some photographs showing the process utilized for the horizontal pours. Figure 5 shows the crew poring the concrete with the bucket. All concrete used at the Lo Residence was poured with a crane-mounted bucket. Figure 6 presents a close up showing the paste rising very quickly.

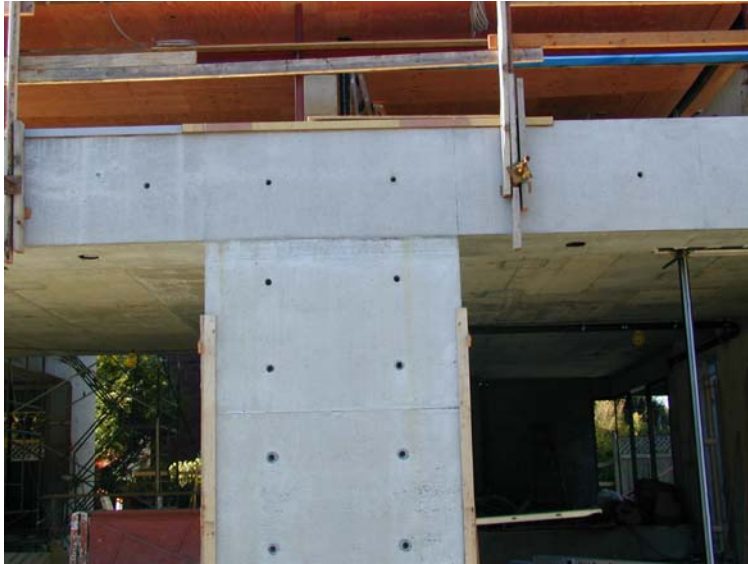
Figure B-3: Close-up of Form Fresh Finish, Wall and Slab Edge Cold Joint
